Tensile properties and color and mass variations of GFRP composites under alkaline and ultraviolet exposures

Guilherme Chagas Cordeiro ¹, Janine Domingos Vieira ²,
Carolina Mattedi C6 ¹

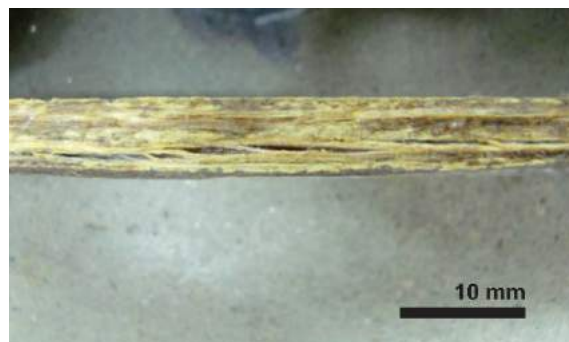
Figure 4: Lateral view of a phenolic composite specimen after 71 days of alkaline exposition.

The mass variation was more pronounced in the alkaline exposure than those in UV/spray cycles, mainly for the phenolic composites. Figure 3 shows that the vinylester specimens presented a 0.7% gain of mass after 71 days of continuous alkaline immersion. The gain of mass for the phenolic composite was about 15% in the same immersion period. In both composite types, the gain of mass over the square root of time increased with a constant rate (linear curves with R^2 higher than 90%). This behavior roughly follows a Fickian diffusion behavior, as it was observed by KIM *et al.* [6]. Severity of alkaline exposure on the loss of mass for polyester GFRP was also reported by CORREIA *et al.* [4]. Results of gain in mass for vinylester GFRP were also previously observed [4,6]. However, the gain of mass determined in this study for phenolic composites was much higher than verified by other works. This behavior can be explained to a progressive visible delamination observed in all phenolic GFRP specimens during the alkaline immersion period. In this case, the longitudinal delamination of the phenolic composite can be attributed to a progressive swelling (Figure 4).

of immersion. However, both alkaline-exposed composites presented significant lower modulus of elasticity values (70%) than the phenolic reference. The loss of tensile strength in the phenolic composites exposed to the alkaline solution was linked with the high mass variation (Figure 3), fiber degradation, and delamination (Figure 4).
